Durability performance of fiber reinforced shotcrete in aggressive environment.

J. P. Kaufmann

Empa, Swiss Federal Laboratories for Materials Science and Technology, Laboratory for Concrete/Construction Chemistry, Duebendorf, Switzerland.

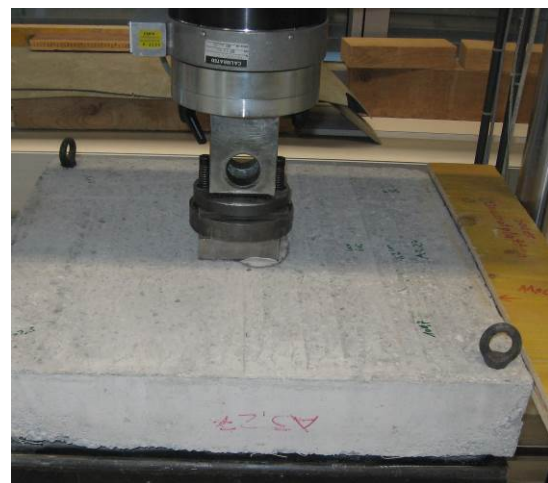
Figure 1 Crack production in interrupted EFNARC square panel test. Test was stopped at a deformation of 3 mm.

Square panel tests according to SIA 162/6 (1999) ‘Testing of steel fibre reinforced concrete’ were performed (test arrangement Figure 1). The load was applied at the center of a square panel. The deflection of the panel was measured continuously. The panel had a dimension of 600 × 600 × 100 mm³. The square support had an edge length of 500 mm and the loading rate was 1.0 mm/min. In order to reduce friction, the plates were polished parallel to achieve a roughness smaller than 1/10 mm. This test method is equivalent to EN 14488-5 (2006) and the European Specification for sprayed concrete guidelines (EFNARC, 2000) with regard to test body dimensions and load application. The absorption of energy (in joules) is determined, in accordance with the directive EFNARC (and EN 14488-5) by integration of the load–deflection curve to a deflection of 25 mm as it is defined in this standard. It should be emphasized that this is in contrast to ASTM C 1550 round panel test, where a larger deflection of 40 mm is applied.

The durability experiments were carried out in a cracked state. Initial crack widths corresponding to the state of use were generated in an interrupted square panel test (SIA 162/6). At the age of approximately 120 days, the test panels ($600 \times 600 \times 100 \text{ mm}^3$) were loaded, while regulating the expansion, until a deflection of $\delta = 3 \text{ mm}$ was achieved and then unloaded in controlled manner immediately after reaching this limit. Four to six cracks (according the mechanical performance of the fiber introduction) crossing the square panels were introduced. Crack widths were typically in the range of 0.5 to 1 mm at a distance of 15 cm from the center and about 2 mm at the center of the square panels. The panels then were exposed to different storage conditions.

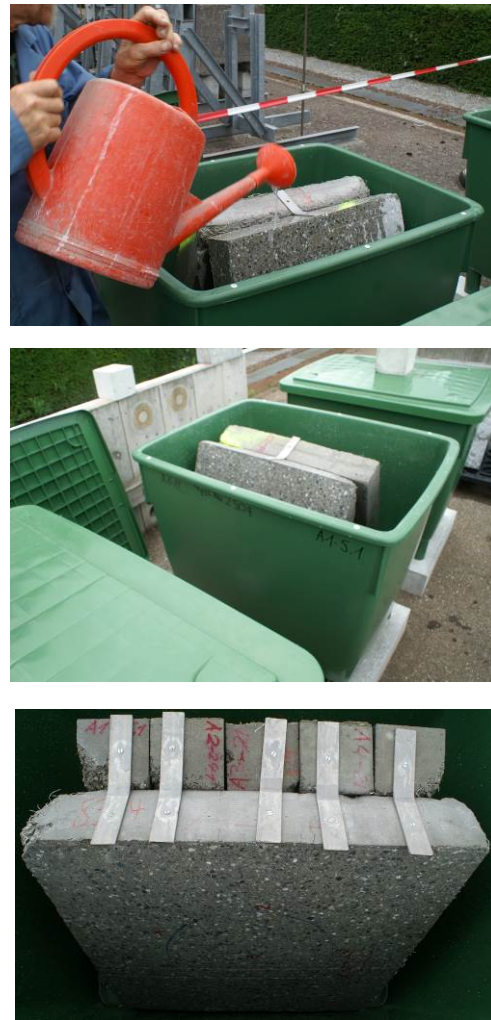
Figure 2 Exposure set-up with application of liquid solutions (top), coverage (center) and different specimens (square panels for mechanical testing and prisms for microscopy, bottom).

Square panels and prisms were exposed to the storage conditions according Table 3. They were placed in large containers, one specimen for each kind of shotcrete for each storage condition. Some of the cracked specimens were stored (with introduced cracks) in a climate chamber at $20^\circ\text{C}/90\%\text{RH}$ (storage 1), others were exposed to the current weather in northern Switzerland (storage 2) and to different solutions. Each specimen was rinsed with five liters of one of the three solutions (always the same) once per week during 1 year. Some of the solution was collected at the bottom of the container and used for rinsing each second time, the other times the solutions were freshly prepared. The filling level of the solutions in the container was not achieving a level to touch the specimens. The containers were covered (except storage 2).

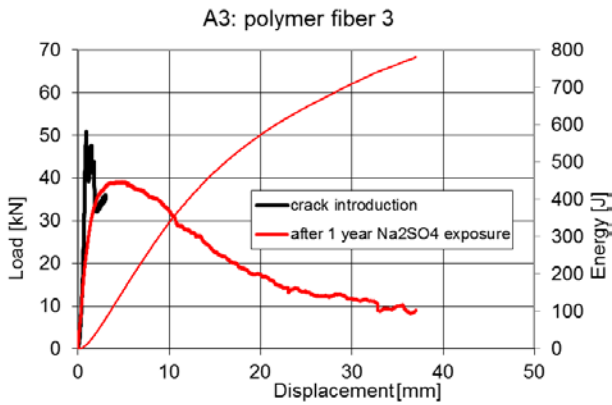
Figure 6 Load displacement curve of polymer fiber 3 (A3) after 1 year of exposure to sulfate-solution ($4\text{g/l Na}_2\text{SO}_4$).

As sulfates frequently are present in tunnel environments, for further illustration, in Figure 4-6 typical load-displacement curves after the exposure to a Na_2SO_4 -solution are compared with the crack introduction curves (up to a displacement of 3 mm only).

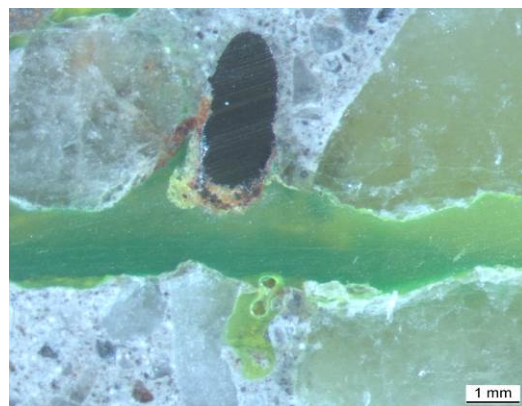
Figure 9 Micrograph of steel fiber near cracks (impregnated for conservation with green resin) at a distance of 35 mm from surface after 1 year exposure in Na_2SO_4 -solution (A1).

This is confirmed by the microscopic analysis of the pre-cracked prism specimens. While corrosion traces in the case of steel fibers close to the cracks are obvious (Figure 9), no visible deterioration of polymer fibers is observed (Figure 10).

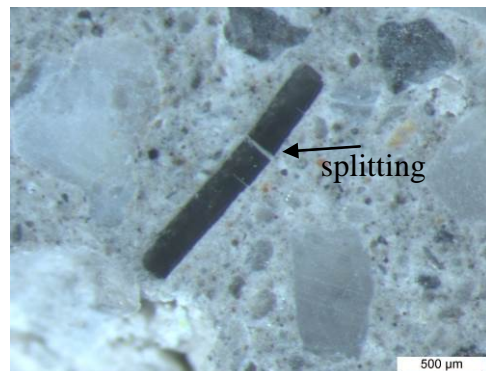
Figure 12 Typical Micrographs of fibers in undamaged shotcrete (storage 3).

Some polymer fibers on the other hand may suffer from damage originating from high pump and spray pressures and hence increased shear forces acting on the fibers during the shotcrete preparation and application. Fibers may fissure or even split completely (polymer fiber A5) along their length (arrows in Figure 12). Figure 12 clearly shows ruptured polymer fibers which are not situated close to a crack. As the ruptured part is filled with cement products, rupture was due to the application (spray) process and not due to mechanical loading of the shotcrete (during pre-cracking for instance). Such rupture, which is along the fibers, however is not critical when the bonding to the shotcrete matrix remains intact.
